Docket No. 217 – Development and Management Plan Inspection

Date: July 22, 2004

Location: Norwalk Substation Expansion

Location: Plumtree Substation Expansion , Bethel

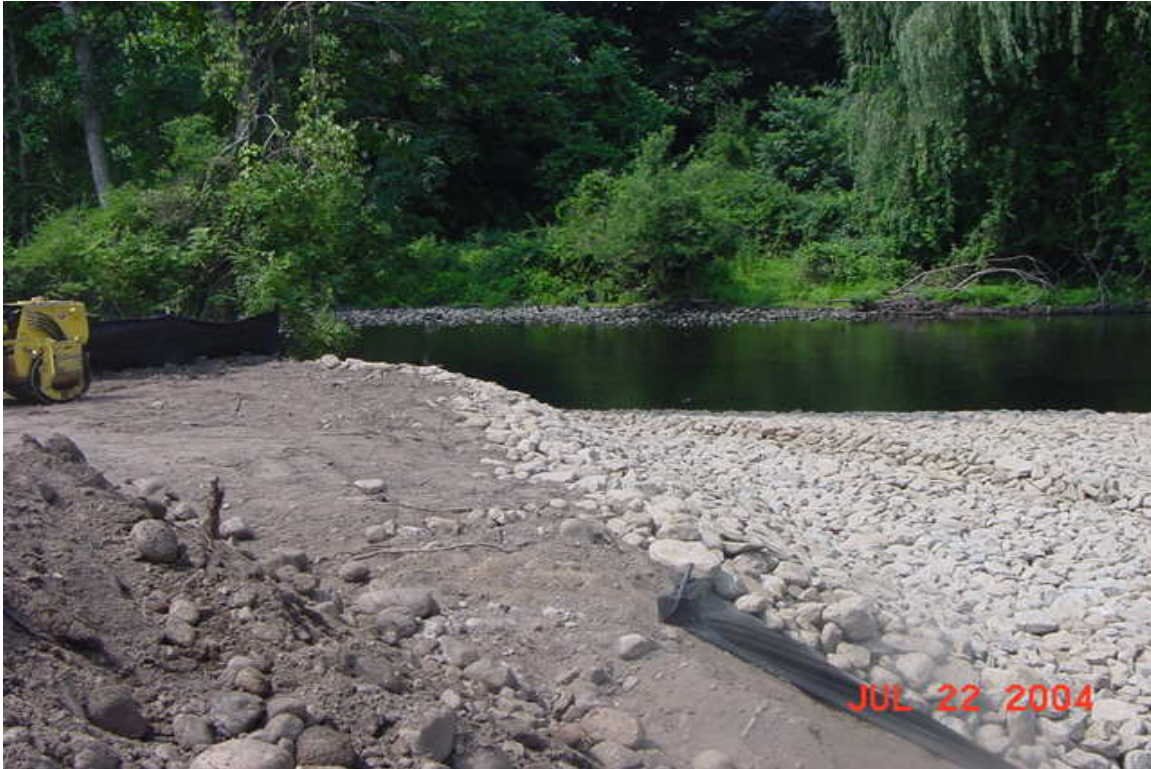
- Work has been completed directly to the river's edge at the southerly end of the channel while a small portion of the channel remains to be tied in with the stone lining. 7/22/04	- No sedimentation was noted in the river at the time of inspection following the tie in on the southern end of the channel 7/22/04

View of the southern end of the overflow channel which has recently been connected to the river's edge. No sedimentation was observed in the river at the inspection. 7/22/04

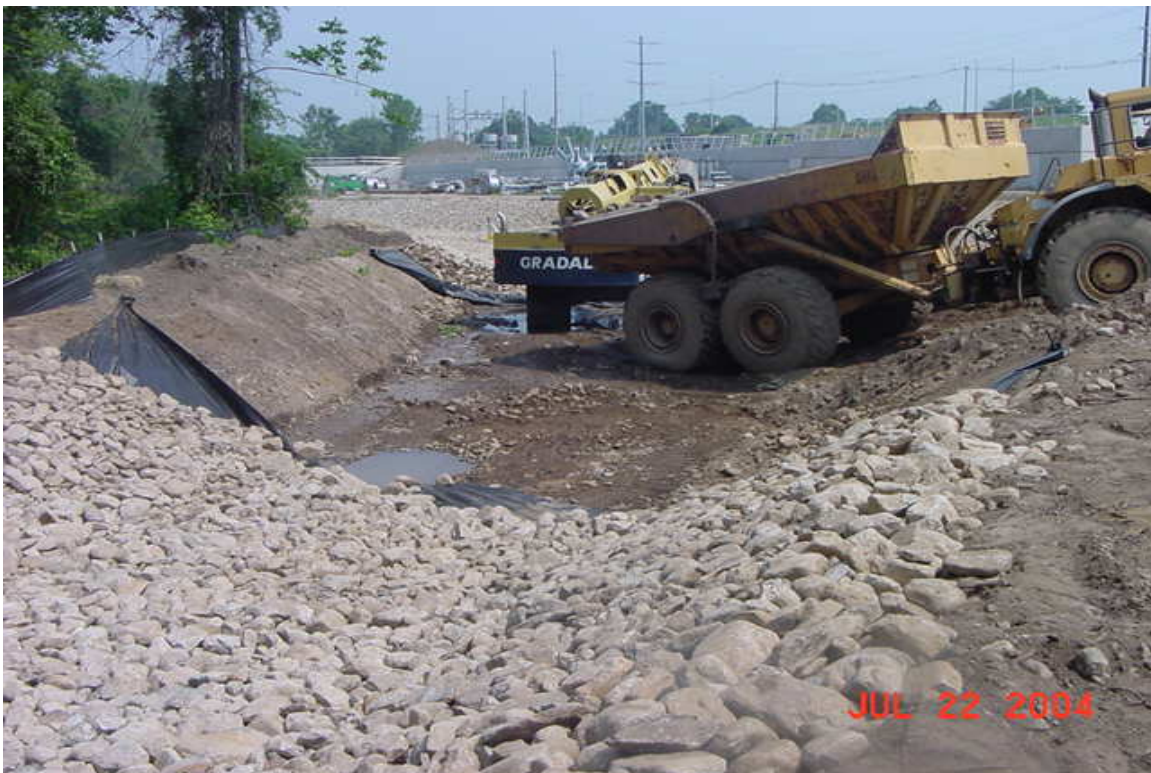
- Work in the overflow channel continues as the fabric liner and cobblestones are being installed well and are including the shape of the meandering internal channel. 6/30-7/22/04	- The channel is still separated from the river by the silt fence and the sheet piling. When the channel is complete, the cobblestones will be used to blend into the existing grade. 7/15-7/22/04

View of installation of liner and cobblestones in the remaining portion of the overflow channel. 7/22/04

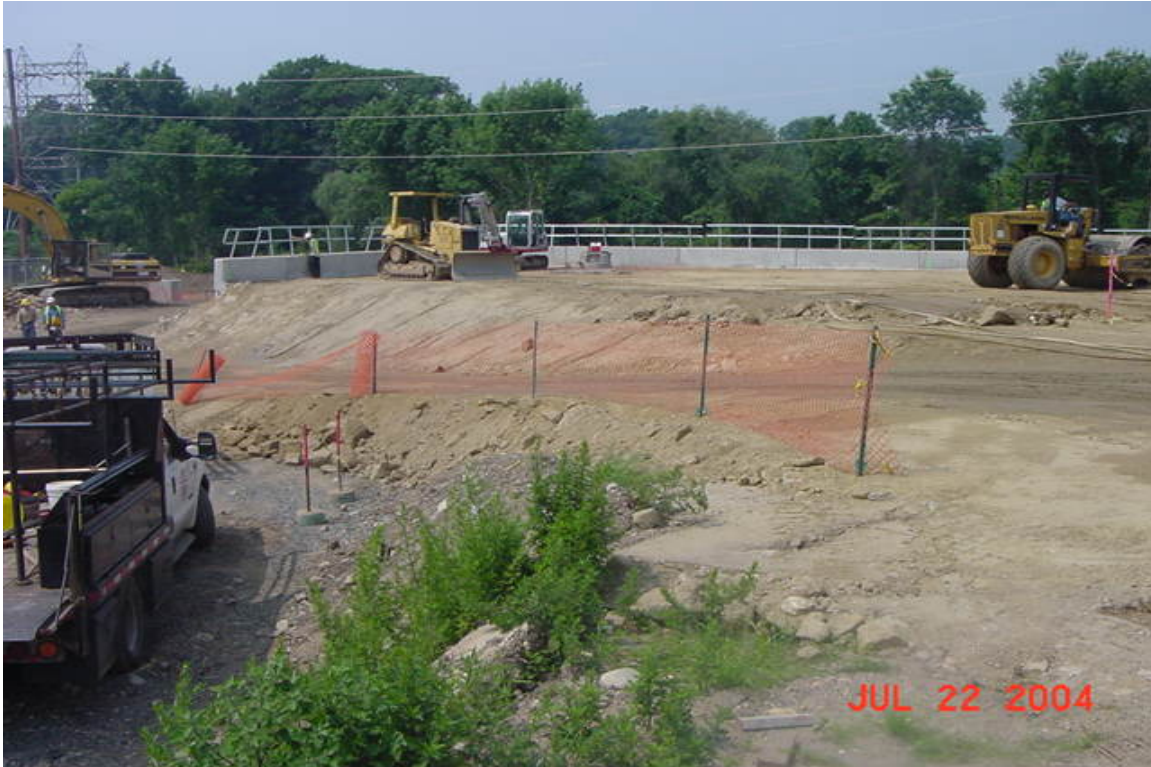
- The topsoil stockpile remains well contained along the retaining wall and fill activities continue to the east of wall #2. 6/30-7/22/04	- The pile will continue to be used where necessary in areas to be grassed in the future and all soil is well contained. 6/30-7/22/04

Overall view of the site fill operation nearing completion near wall #2. 7/22/04

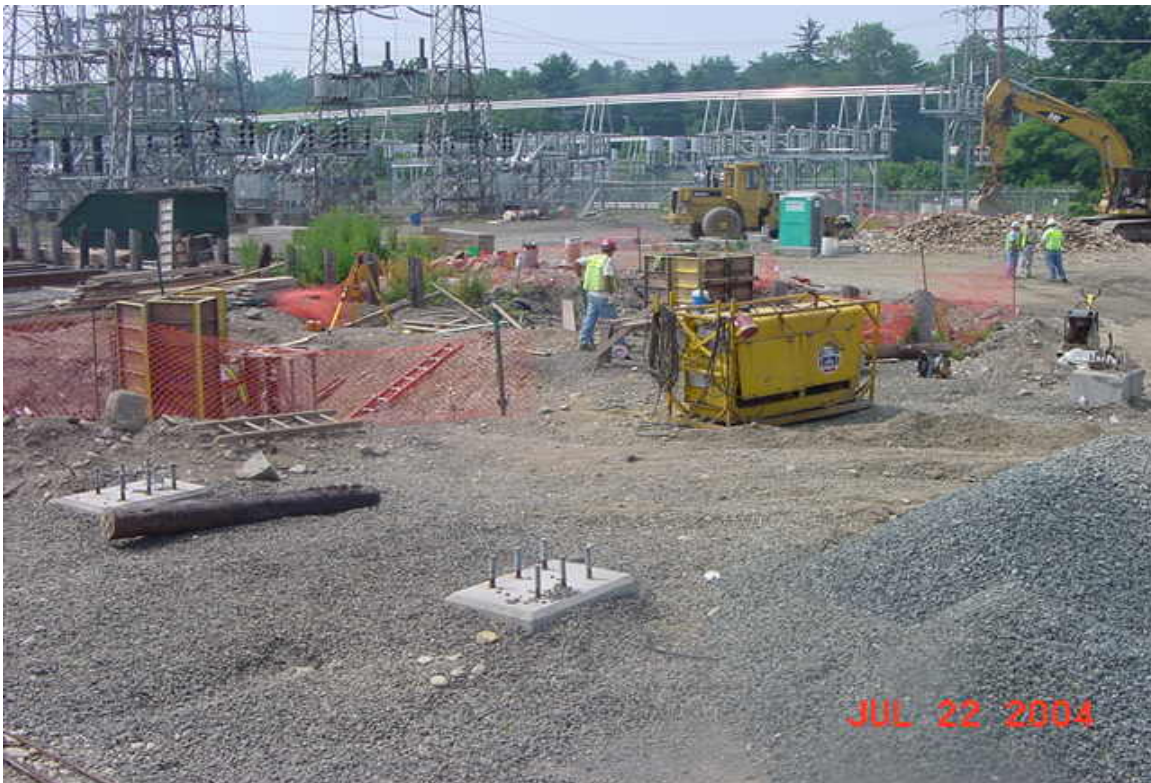
Work on excavations for footings and foundations of future structures continues. All areas are well contained. 7/22/04

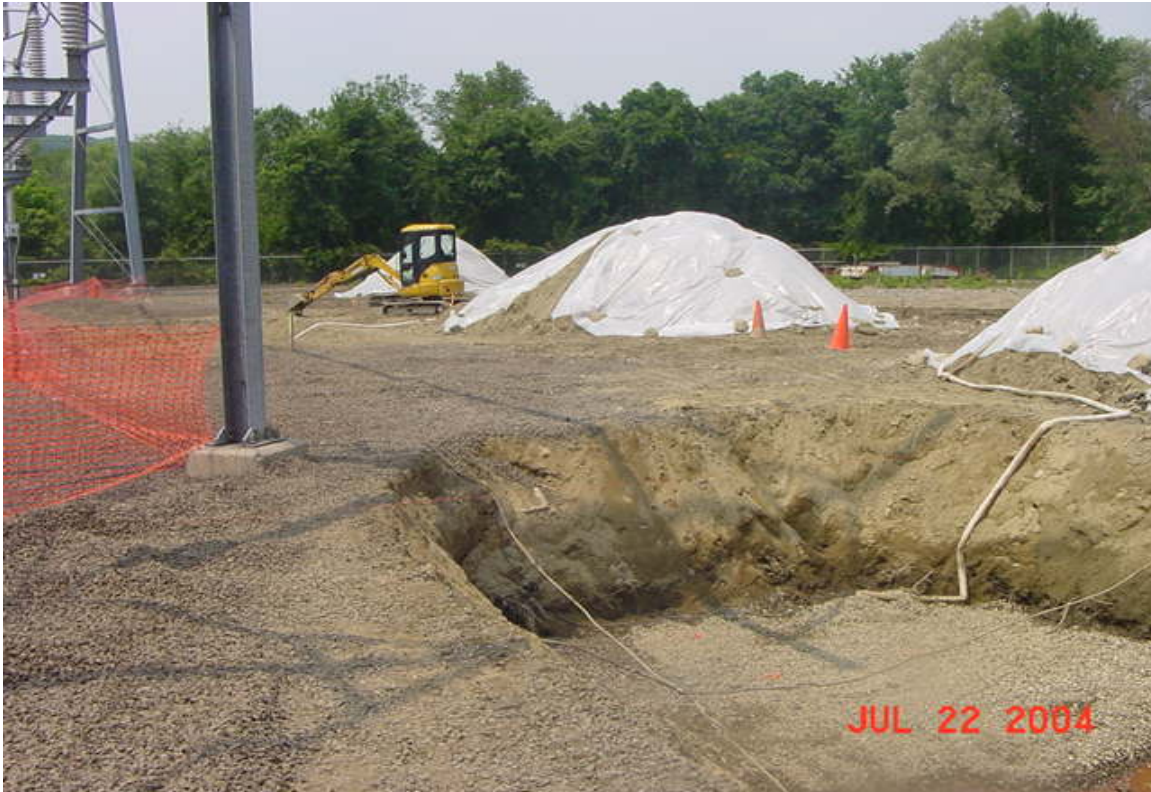
View of several excavations and stockpiles at the Plumtree station. Areas are well contained and the stockpiles have been covered in plastic. 7/22/04

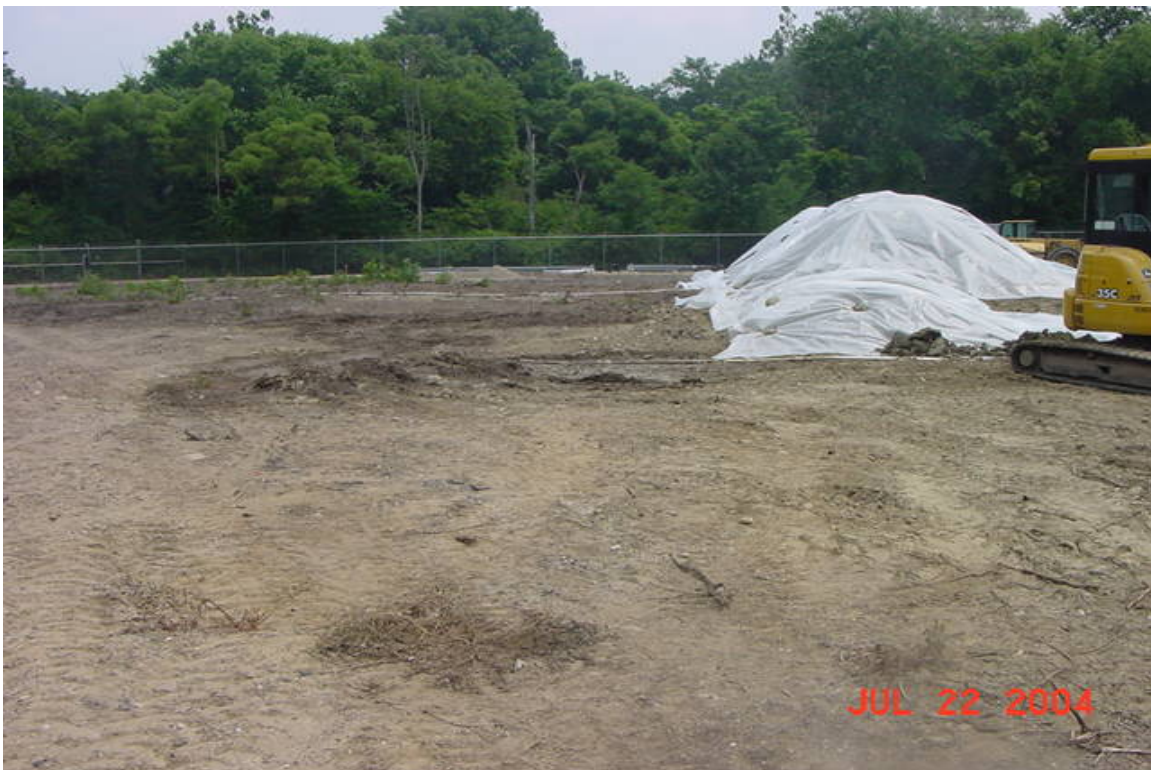
Second view of work at Plumtree. All excavations and stockpiles are contained and located well away from environmentally sensitive areas. 7/22/04
